Solutions against hydro-abrasive erosion

Optimized design and SXH™ coating

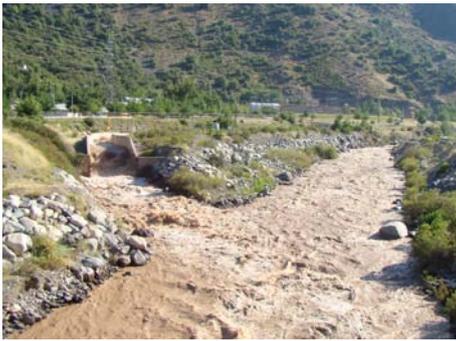
▲ Alfalfal (Chile): Highly particle loaded water leading to very extensive damages

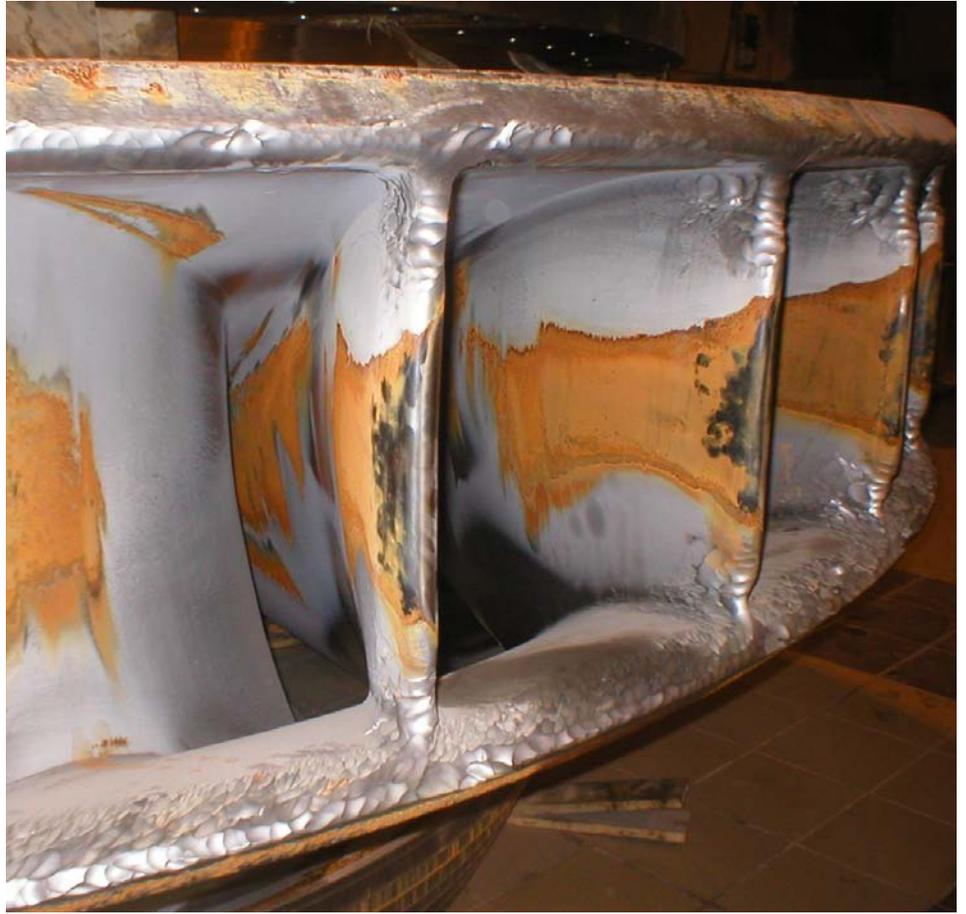
▲ Nathpa Jhakri (India): Uncoated runner with extensive erosion damages

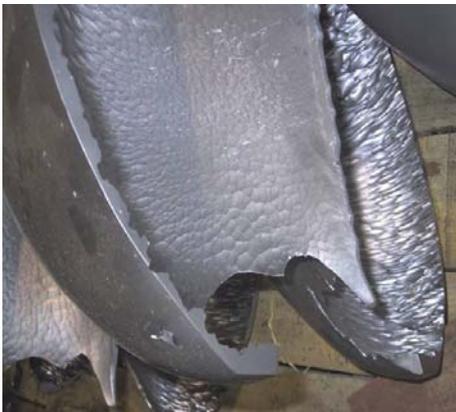
▲ Malana (India): Uncoated Pelton runner after one monsoon season

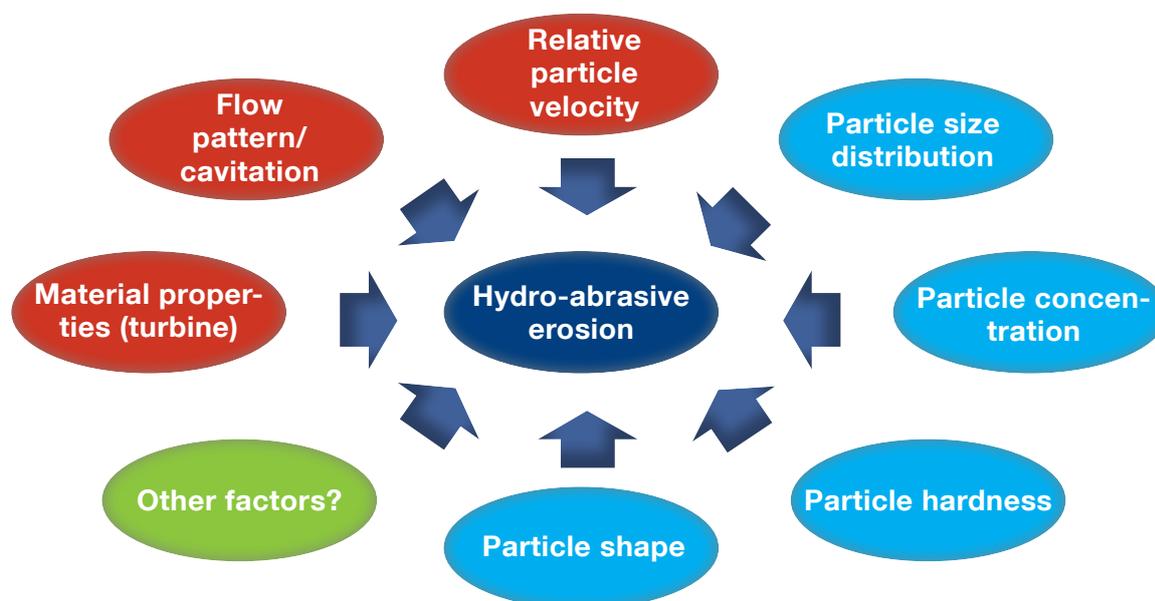
▲ Hydro-abrasive erosion is depending on design and operational parameters (red) and on the other hand on the particle parameters of the water (blue) which cannot be influenced and which vary highly with time.

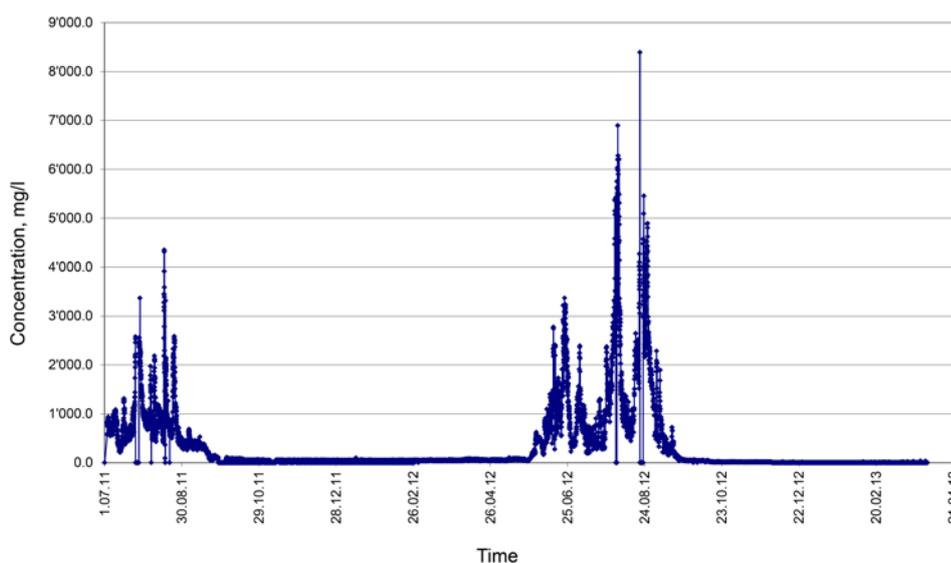
▲ Long term sampling showing fluctuation of concentration

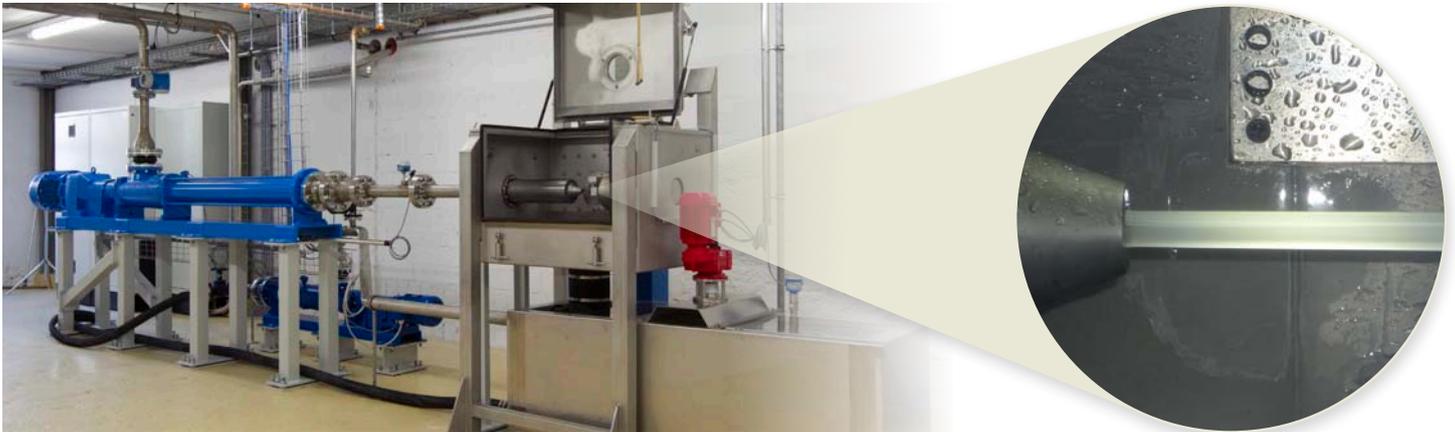
▲ Test rig for erosion tests

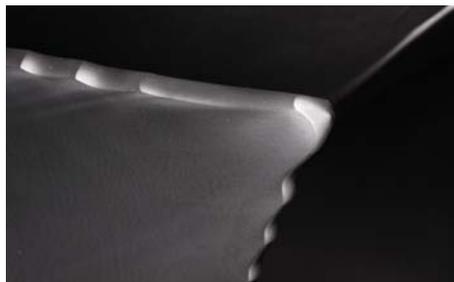
▲ Erosion on a splitter of a Pelton runner

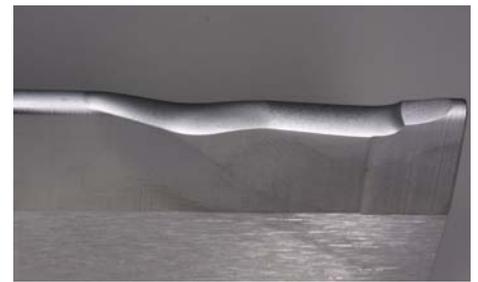
▲ Erosion on a Pelton splitter sample, tested in the wear-lab

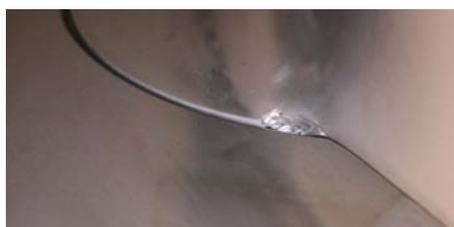
▲ Damage on guide vane

Combining feedback from customers and internal know-how on computational fluid dynamics, areas with high damages are analyzed to see if design changes are possible.

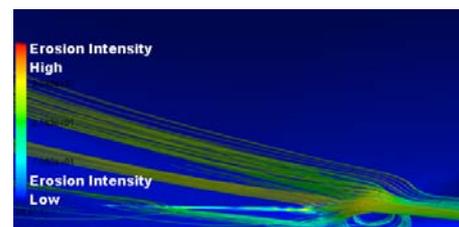
▲ CFD analysis of the same area

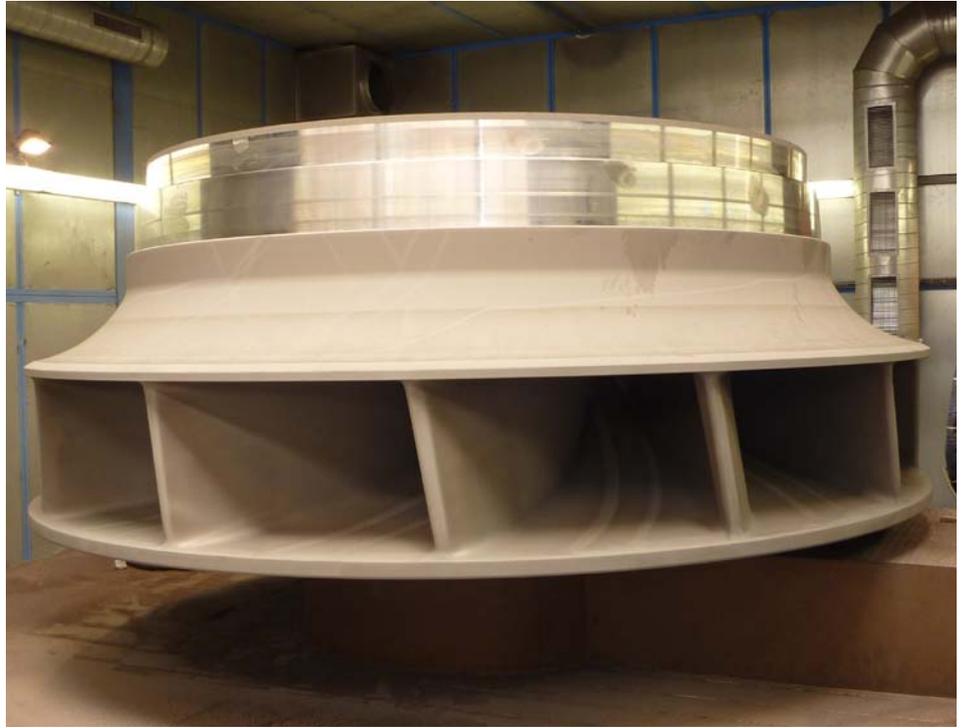
▲ Fully coated Francis runner (Karcham Wangtoo, India)

- Possibility to fully coat Francis runners by robot
- Increased stabilization of the splitter for Pelton runners (SXH™8X)
- Repair of hardcoating

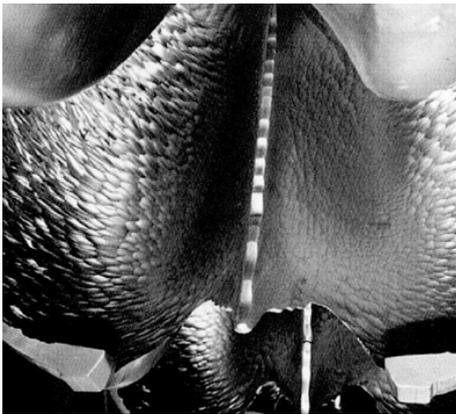
▲ Uncoated Pelton runner after 38,000 t (Alfalfal, Chile)

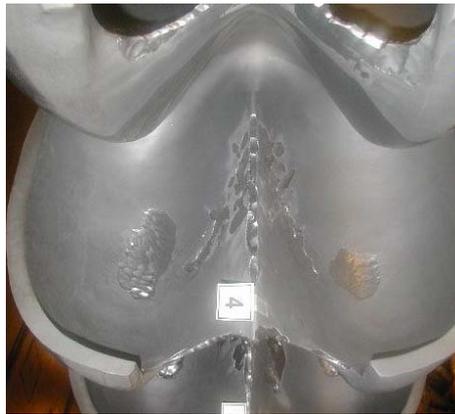
▲ SXH™70 after 120,000 t (Alfalfal, Chile)

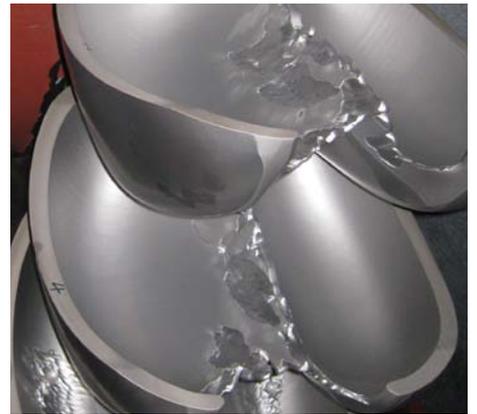
▲ SXH™8X after 183,000 t (Alfalfal, Chile)

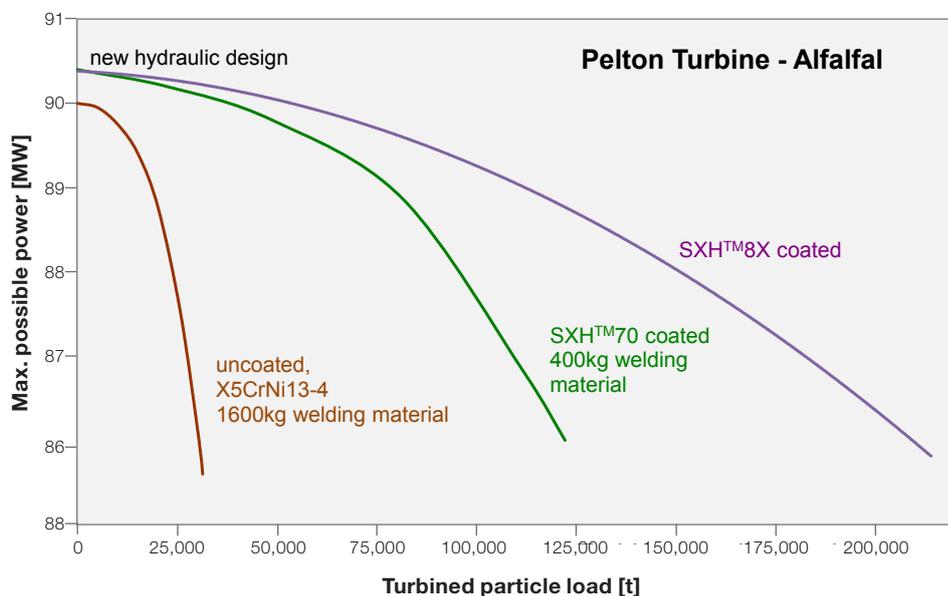
Alfalfal (Chile)

Maximal possible power depending on the amount of turbined particles for an uncoated Pelton runner, a runner with standard SXH™70 coating and a runner with increased stabilization of the splitter, with SXH™8X coating.

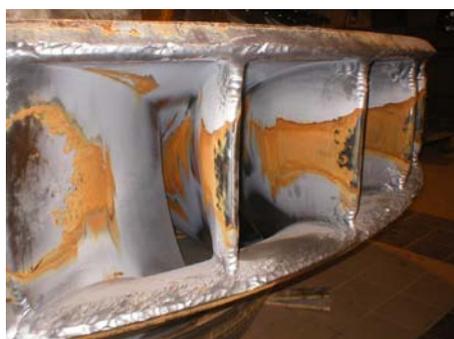
Damages after one year of operation are on a fully coated runner very small compared to the uncoated runner. Therefore almost no efficiency losses occur.

▲ Uncoated: After one year of operation

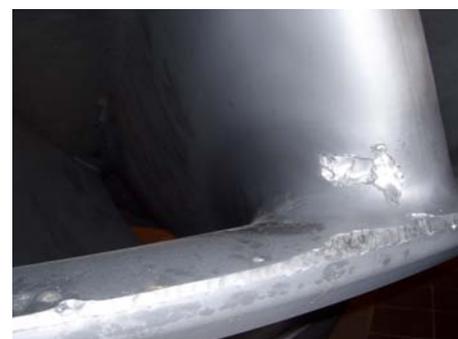
▲ Coated: After one year of operation

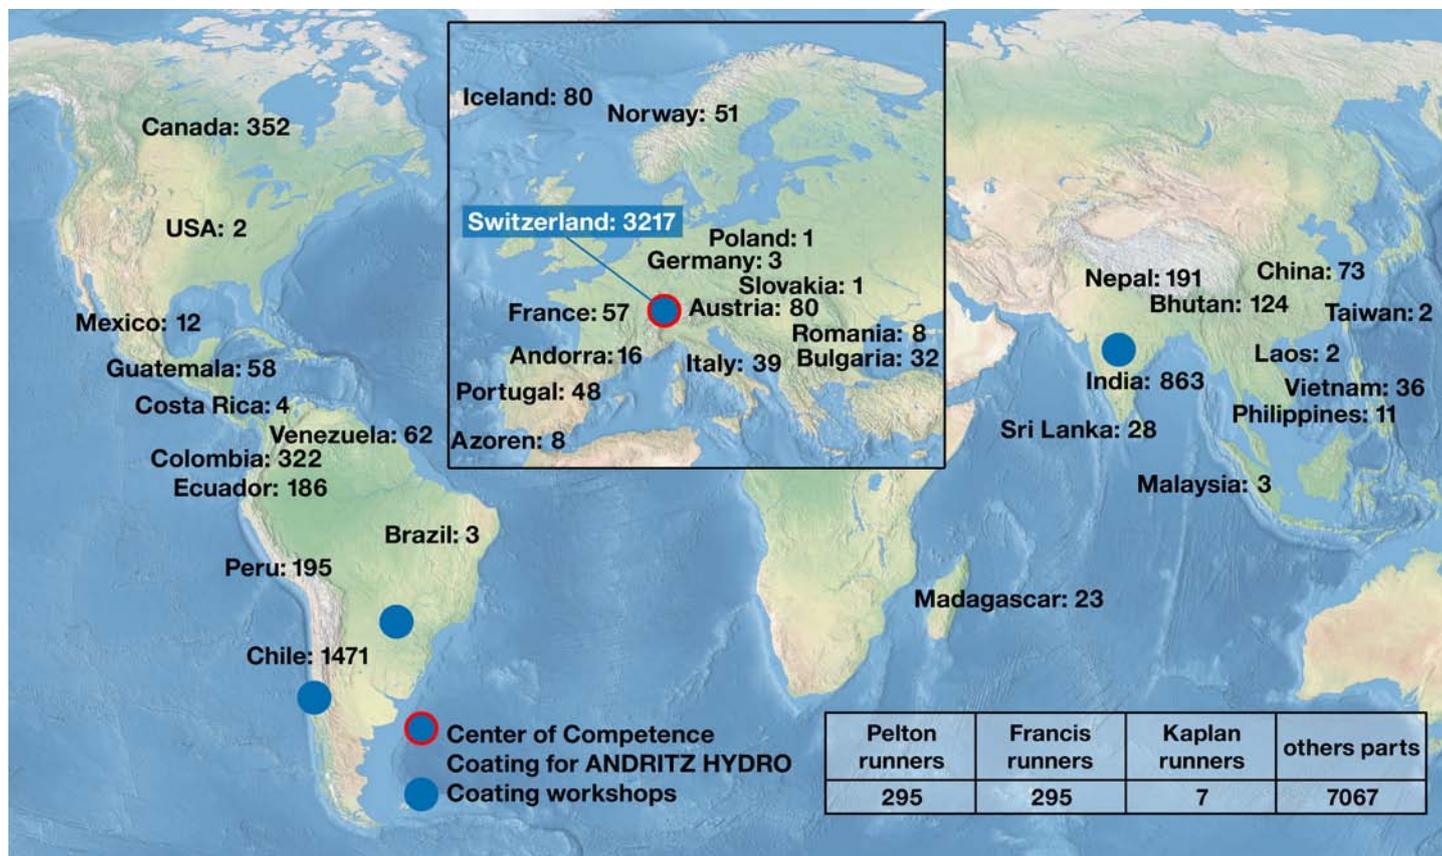
Coated parts by ANDRITZ HYDRO

Figures present the number of coated parts by ANDRITZ HYDRO.
